## Extending and balancing Elevators

1/23/04

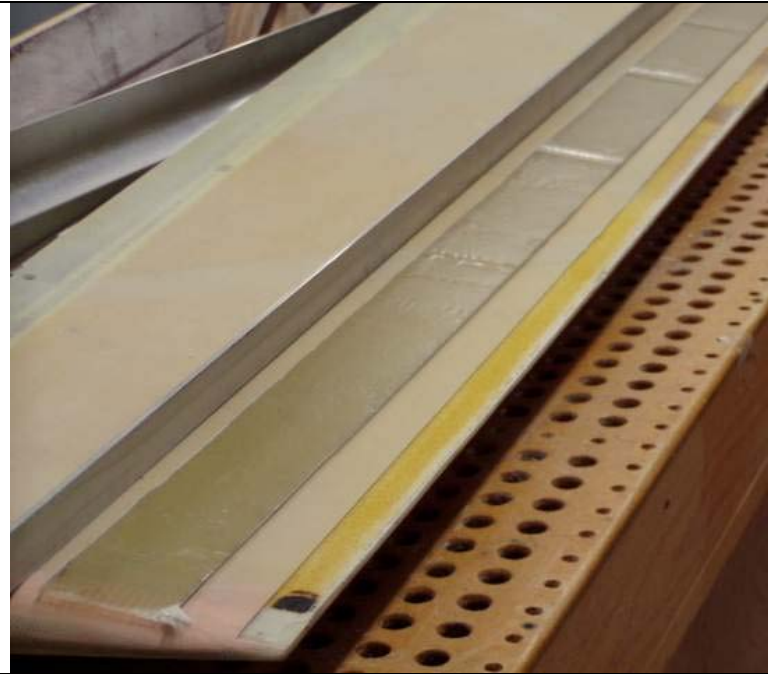
The top of the elevator is flat, so I set a straight edge on the surface, and used a router bit to machine off a 3/4 inch wide groove that was about as deep as a 5 layer bid piece that I had laid up on a flat table. Here you can see the recess, the straight edge, and the multi-layer bid that was made up.

In hind-sight, it would have been better to lay up the extension on a piece of glass, using just peel-ply on the top surface to get a straighter piece. My layup had some small residues from the plastic folds, it worked out okay, but just caused more filling and sanding later.

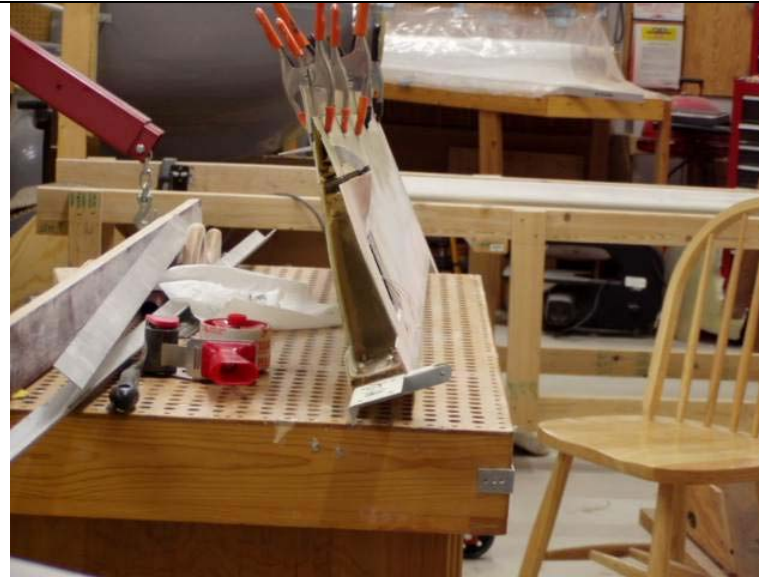
Here the strip is being bonded into the recess, while being held flat by an aluminum angle. The aluminum angle ensured that the trailing edge would be straight, and aligned with the top surface. The adhesive used was Aeropoxy – 6228.

This side of the elevator has the trim tab. I just aligned the trim tab with the edge of the elevator, and bonded it all at once. Only cut it apart after filling and sanding.

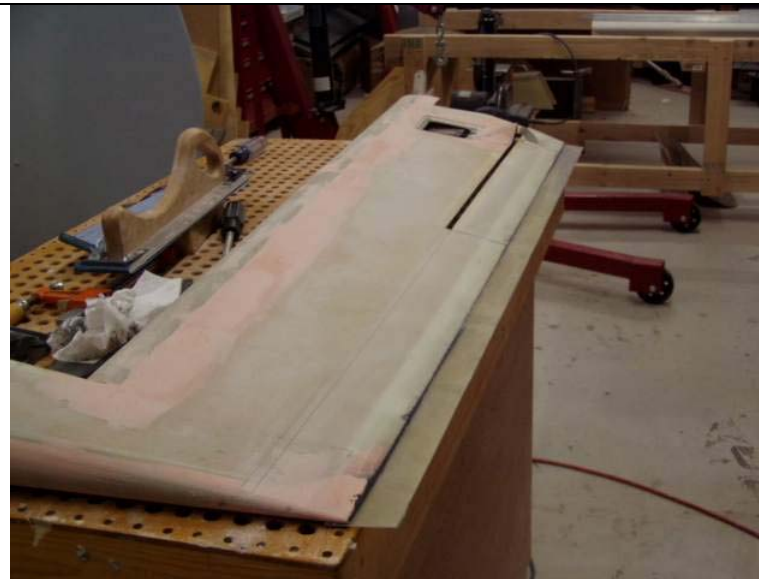
View of the bottom of the elevator, showing strip bonded in place, still needs to be filled. I elected to make the transition from the edge of the trim tab back to the rear of the elevator.

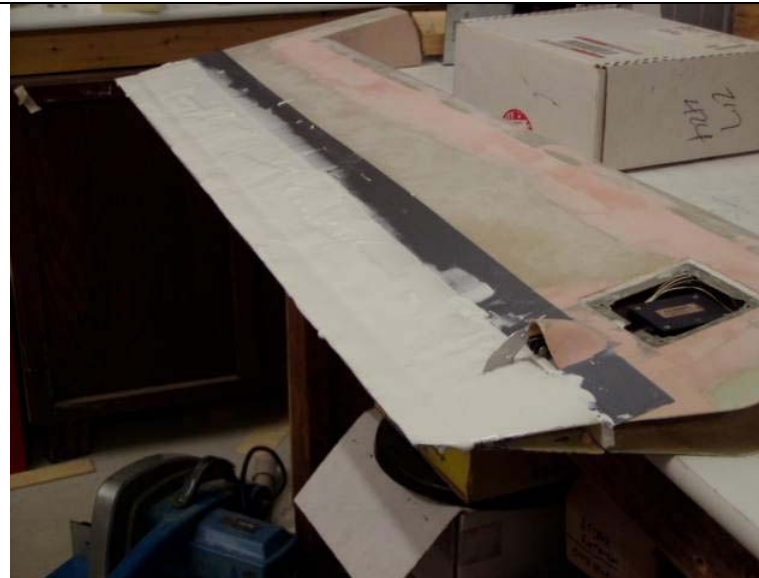
After cure, I then masked off a region (duct tape) and applied a thick layer of Micro to fill the gap.

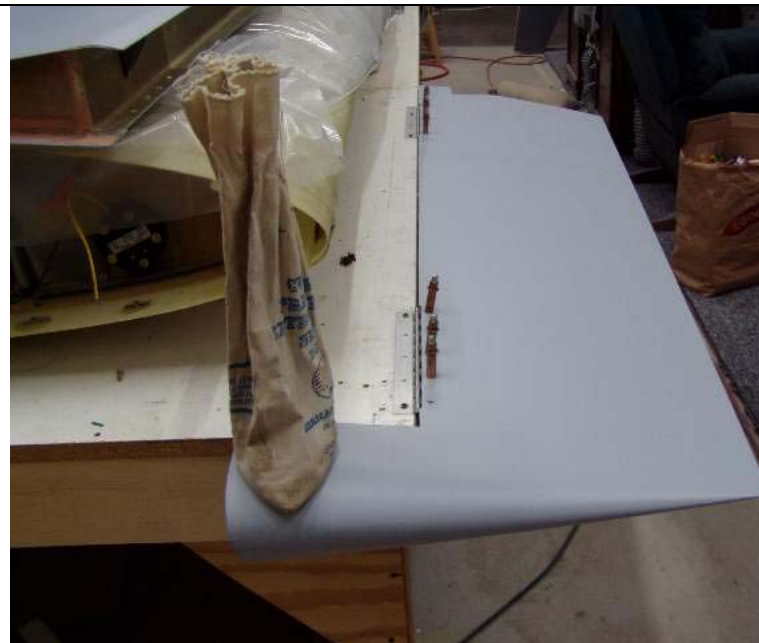
After much sanding and filling, I then primed the elevators, and they look pretty good, however they are no longer balanced. That is they need to have more weight in the horn area.

As those who have done this know, there is little room for any more lead in the horn, so I tried to come up with another way of balancing it.

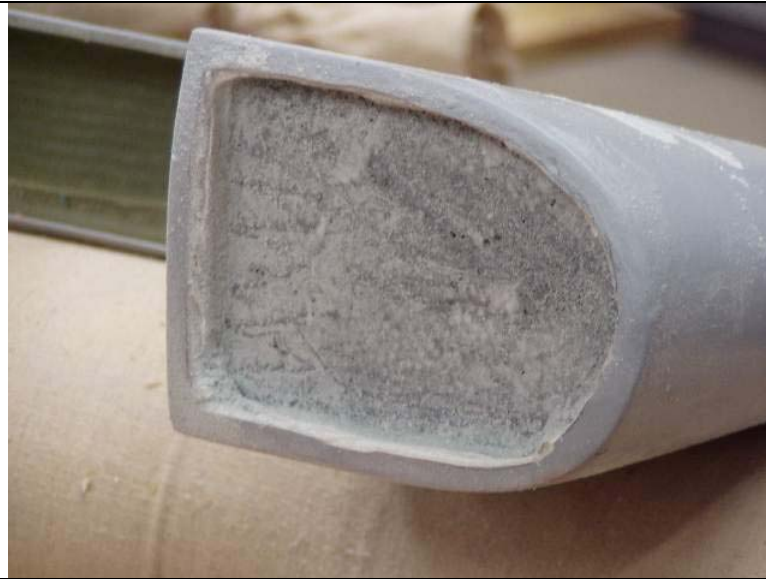
I routed out the foam and fiberglass at the front of the horn, this shows the cavity. The foam has been routed out to the lead shot that previously balanced the elevator.

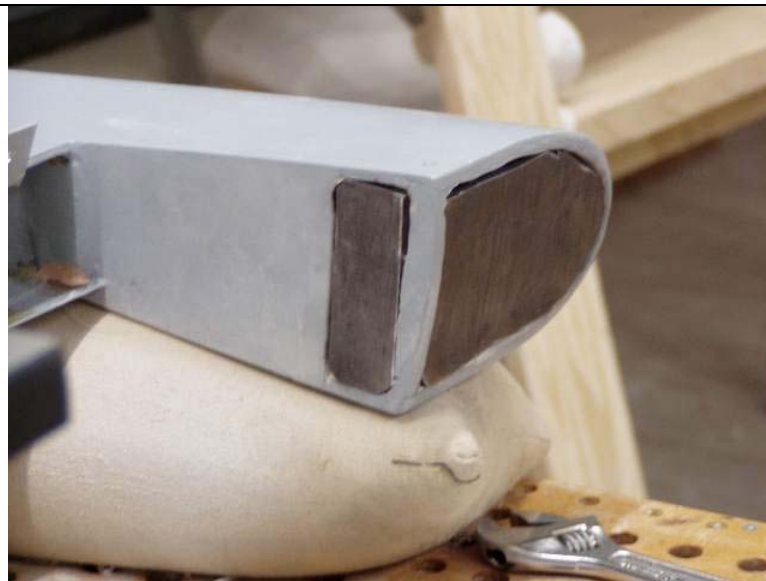
I was able to put two 1/8" sheets of lead into the cavity, and then cut a 1" x 2.7" piece on the side and put two 1/8" sheets into this space. Lead sheet obtained from McMaster-Carr, and is available in many thicknesses.

This almost brings the elevator back into balance, without changing the dimensions of the horn. The half **without** the trim servo is very slightly overbalanced, and the half with the servo is not quite balanced. Overall, I judge it to be close enough.

Some others had mentioned cutting out some of the lead shot and pouring molten lead into the cavity, to increase the density. I wanted to avoid this if possible. The lead has been covered with micro and faired to the surface.
